**15000 kVA JES  
AYDIN-TURKEY**

**Caner CANDEMİR  
Service Manager**

**10-11/01/2016**

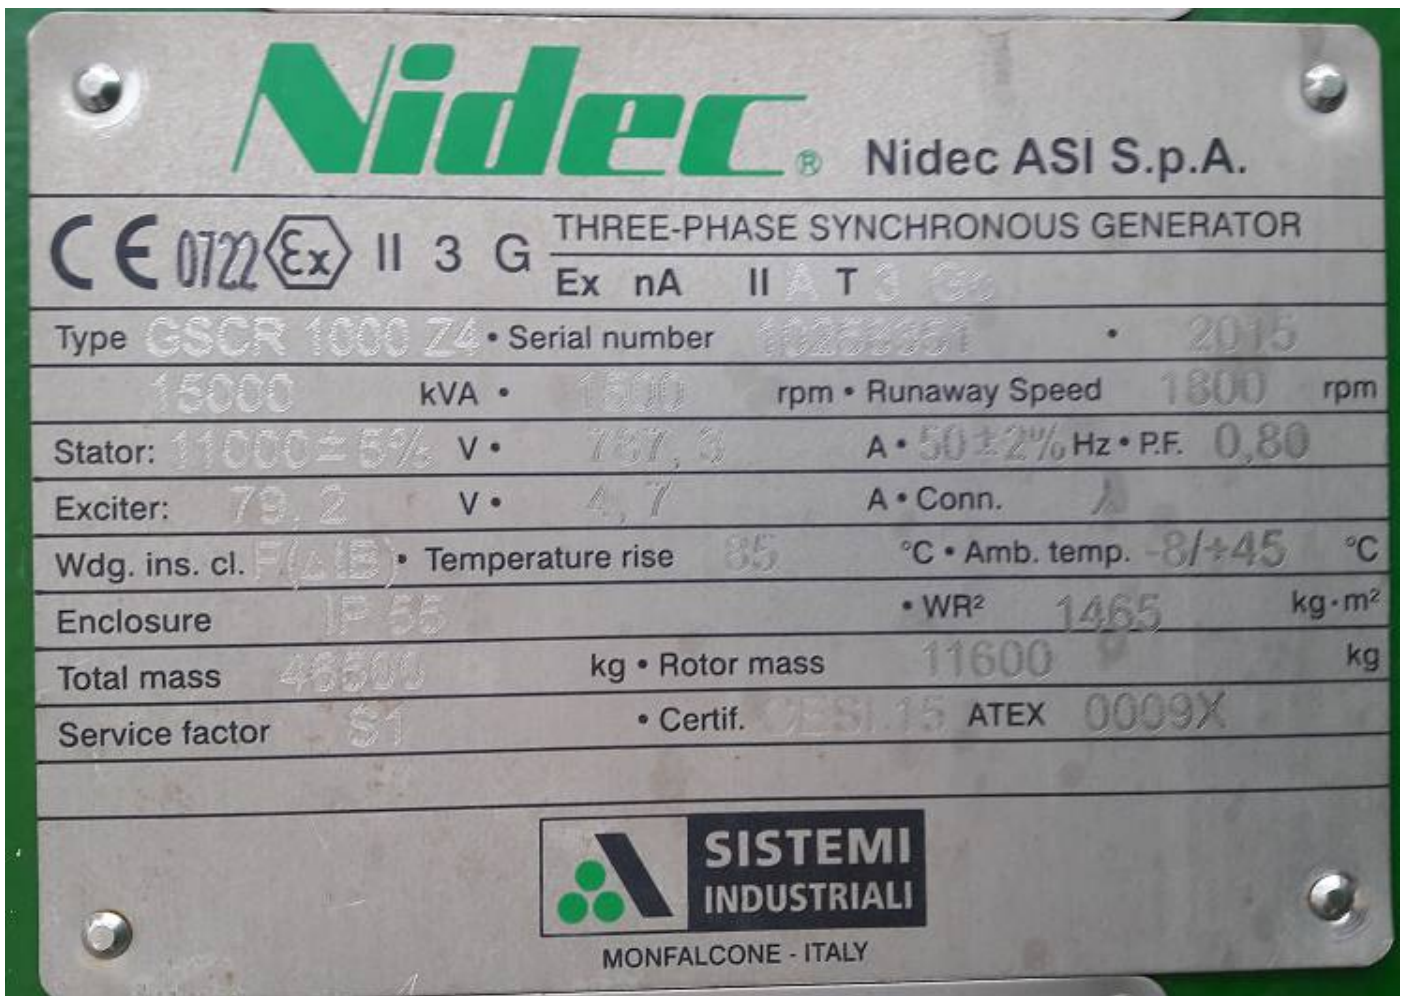
**GENERATOR LABEL**

Type: GSCR 1000 Z4  
Serial number: 10258351  
P: 15000 kVA  
U: 11000 V  
I: 787,3 A.  
Uexciter : 79,2 V.  
Iexciter: 4,7 A.  
N: 1500 rpm

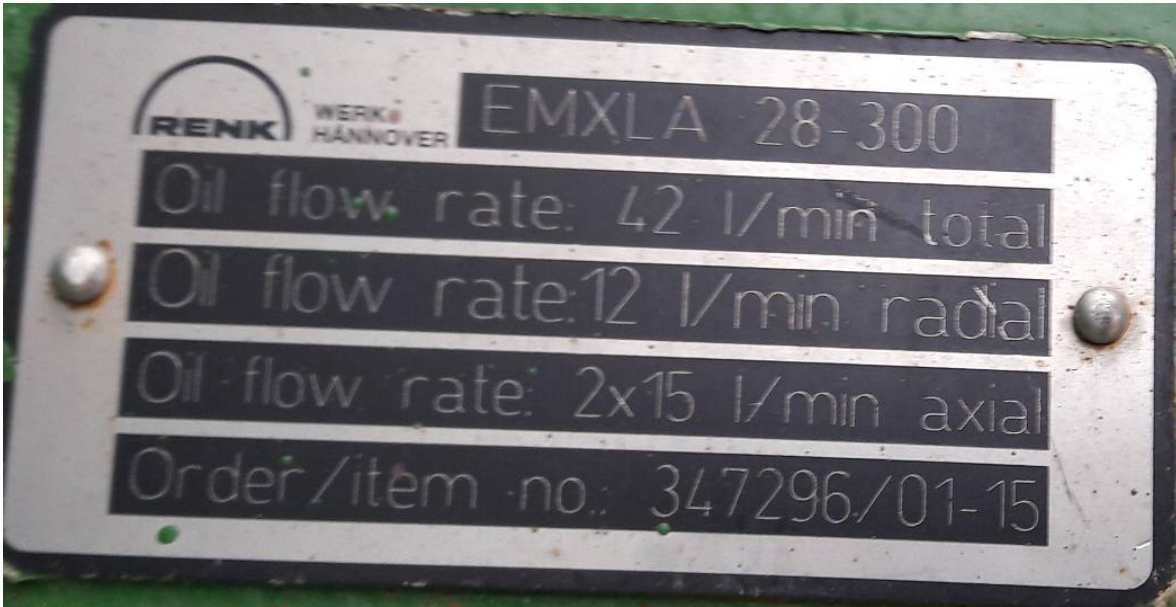
Non insulation bearing

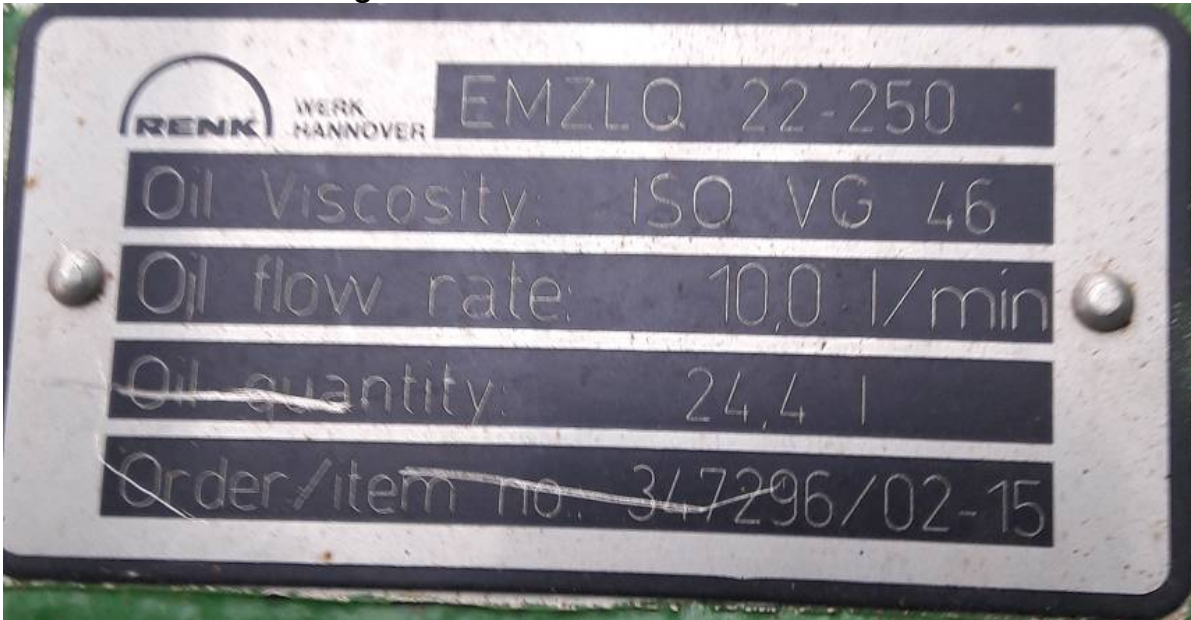
insulation bearing (Exciter side)

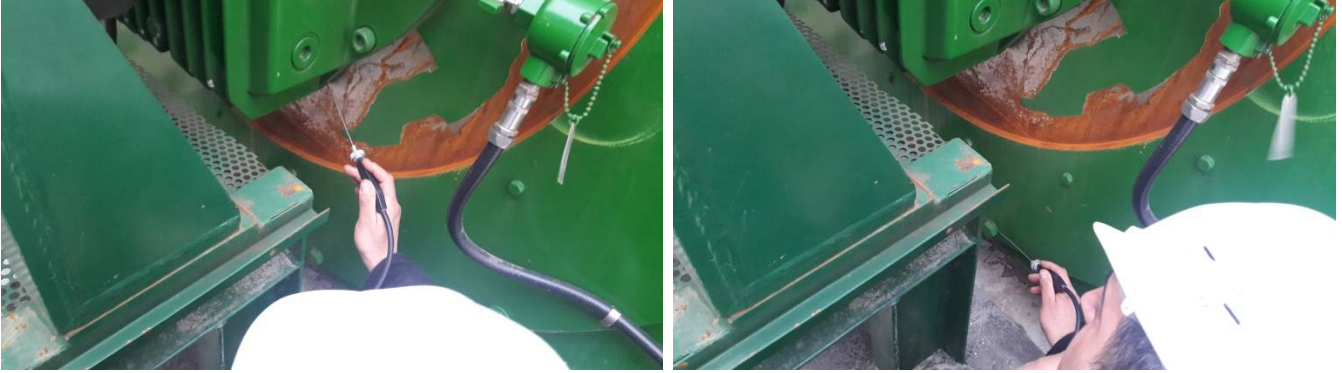
### HEADSET LISTENING

We listened to the voice of both bearing. There was not a problem for sound at the bearings.

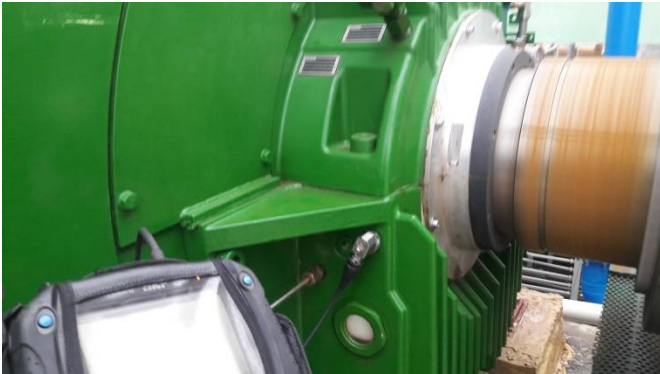
### VIBRATION ANALYSIS

<u>Machine name</u>	<u>POINT name</u>	<u>Date/Time</u>	<u>Last value</u>	<u>Units</u>	<u>POINT description</u>
Nidec-Karkey	MOTOR-HV	10.01.2016 12:57:05	0,967	mm/s	Insulated bearing side horizontal vibration (mm/sn RMS)
Nidec-Karkey	MOTOR-VV	10.01.2016 12:59:11	0,363	mm/s	Insulated bearing side vertical vibration (mm/sn RMS)
Nidec-Karkey	MOTOR-AV	10.01.2016 12:59:30	1,264	mm/s	Insulated bearing side axial vibration (mm/sn RMS)
Nidec-Karkey	MOTOR-NHV	10.01.2016 13:01:26	1,669	mm/s	Non insulated bearing horizontal vibration (mm/sn RMS)
Nidec-Karkey	MOTOR-NVV	10.01.2016 13:05:02	1,143	mm/s	Non insulated bearing vertical vibration (mm/sn RMS)
Nidec-Karkey	MOTOR-NAV	10.01.2016 13:05:23	1,399	mm/s	Non insulated bearing axial vibration (mm/sn RMS)

is not any problems for vibration measurement for bearing

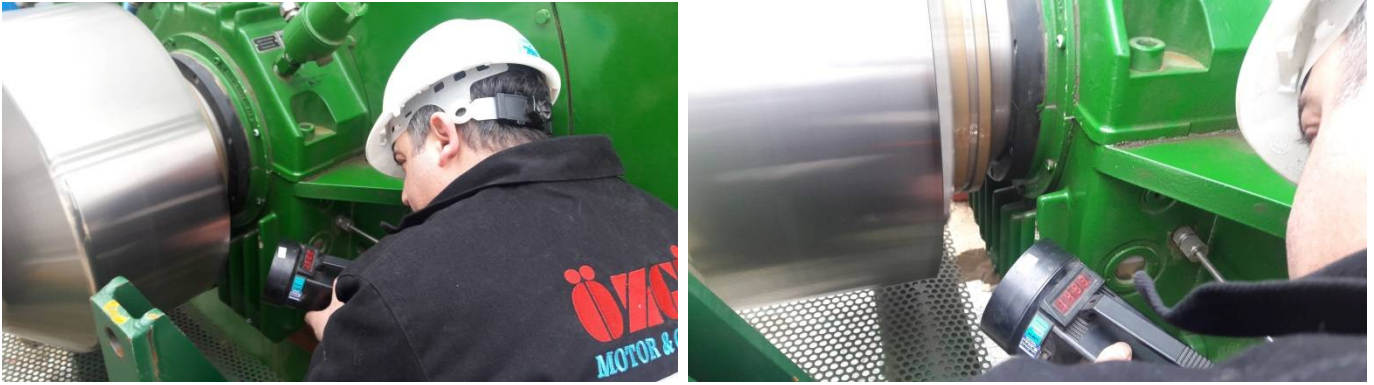
## STROBOSKOP CONTROL

is not any problems for stroboskop control for rotating shaft  
probably sound source as coupling

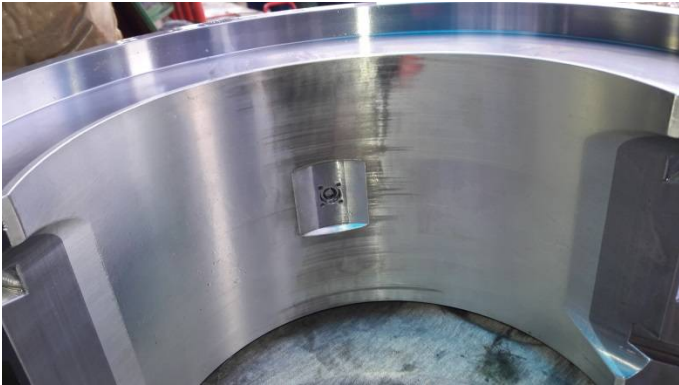
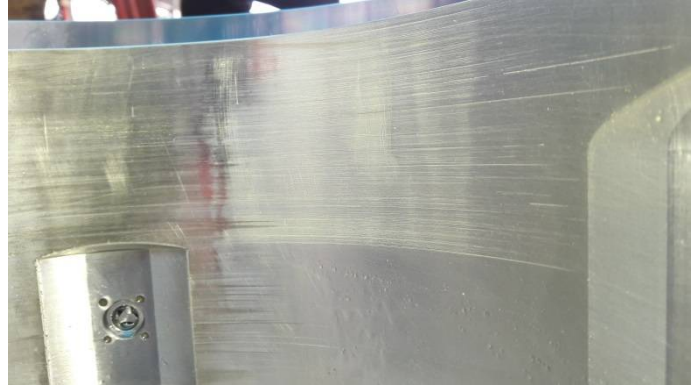
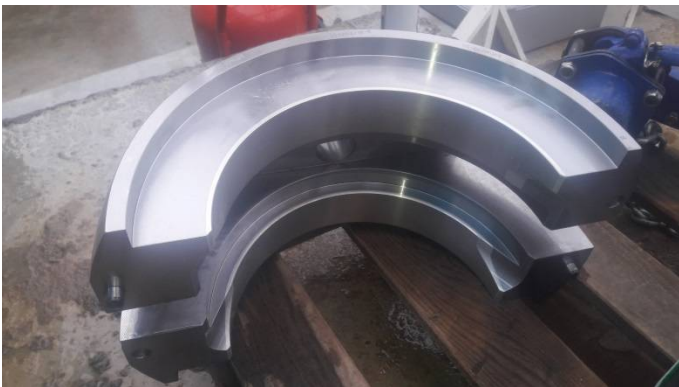
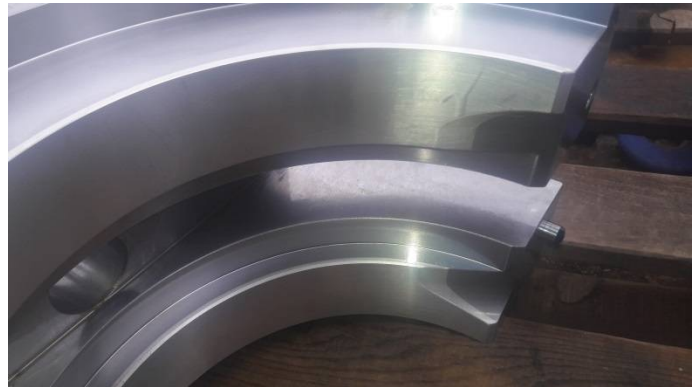
**There is no problem in the white metals belonging to upper and lower shells  
There are small scratches on the direction of rotation of the lower white metal  
it's may be reasons the oil must be small metal parts**

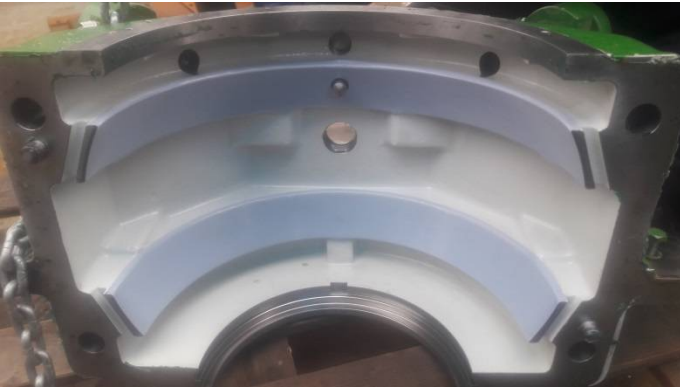
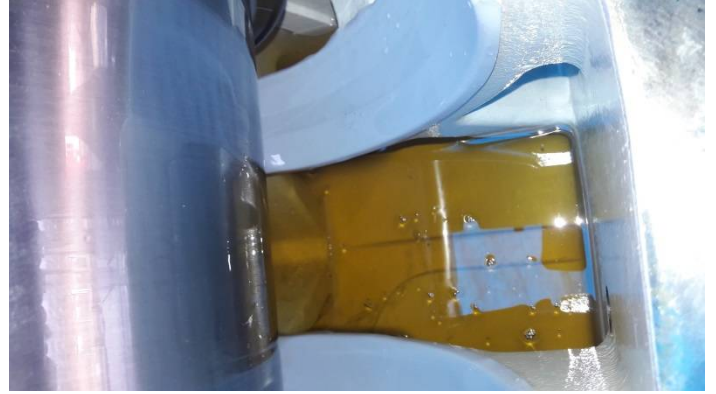
**There is no problem in the upper and lower housing and inulations**

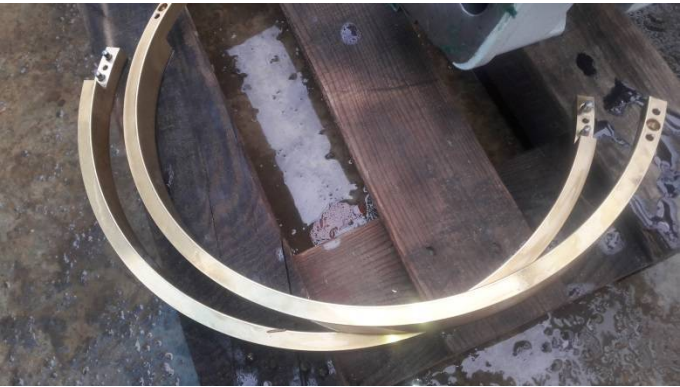
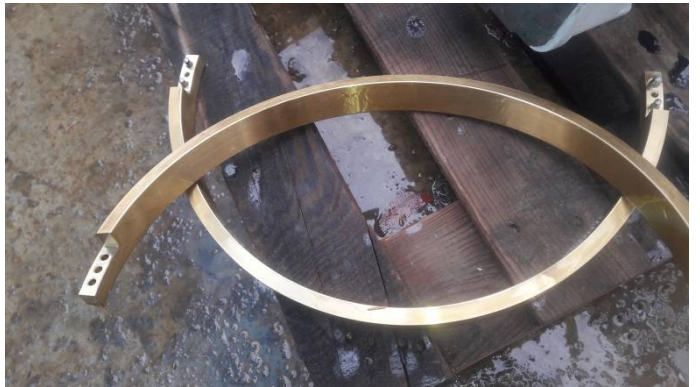
**There is no problem at the oil rings**

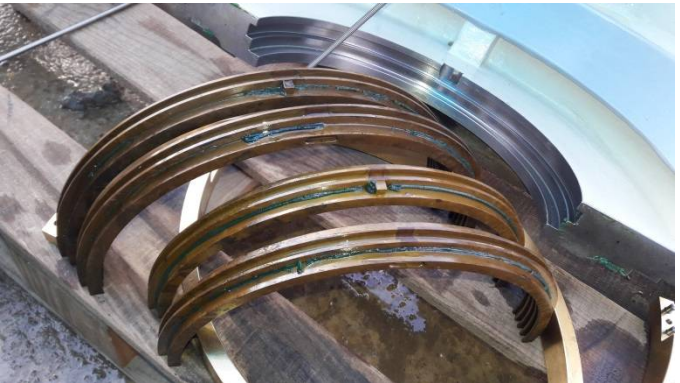
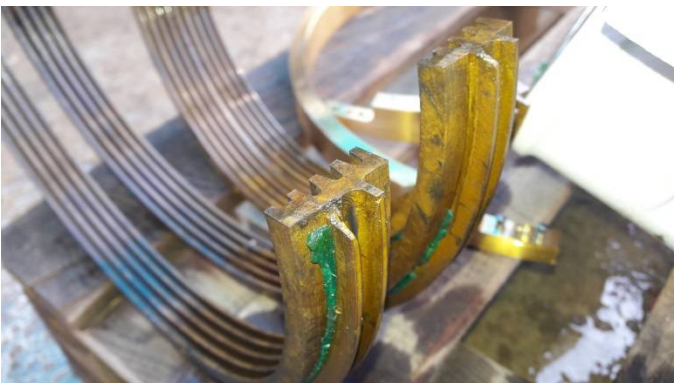
**There is no problem at the labirent seal**

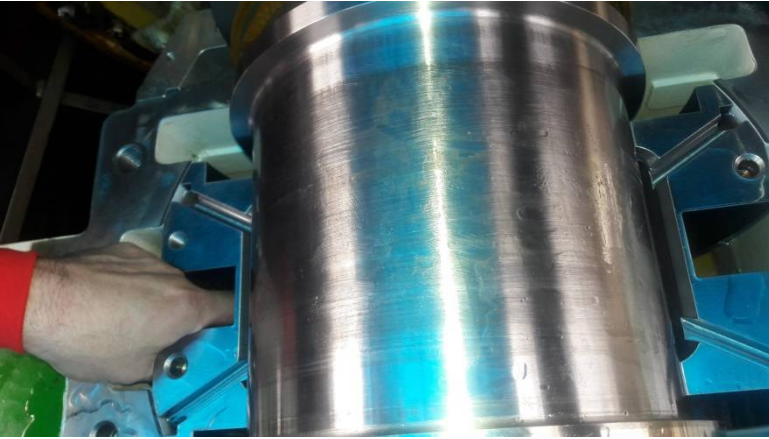
**There is no problem at the bearing journal**

**There are small scratches on the direction of rotation of the surface**

**it's may be reasons the oil must be small metal parts**

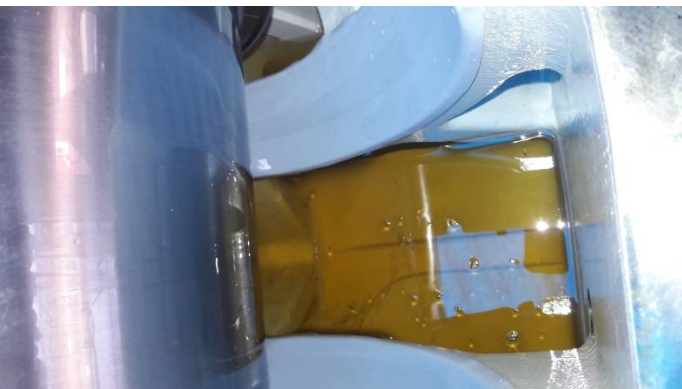
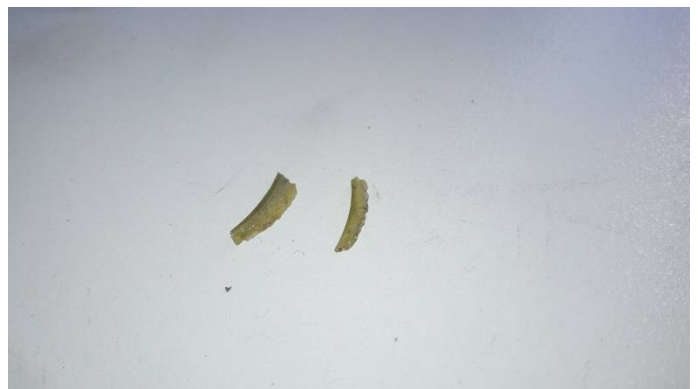
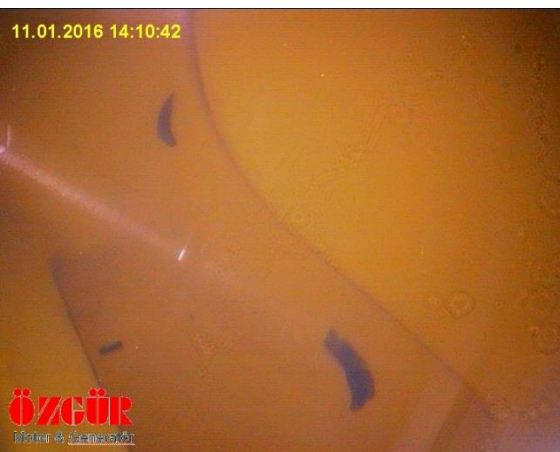
**There is no problem at the oil**

**There are 3-4 pcs small part in to lower housing**

**They are seal part and curil T part**

**All were removed**
