**15000 KVA  
AYDIN**

## GENERATOR LABEL

## RUNNING INSPECTION

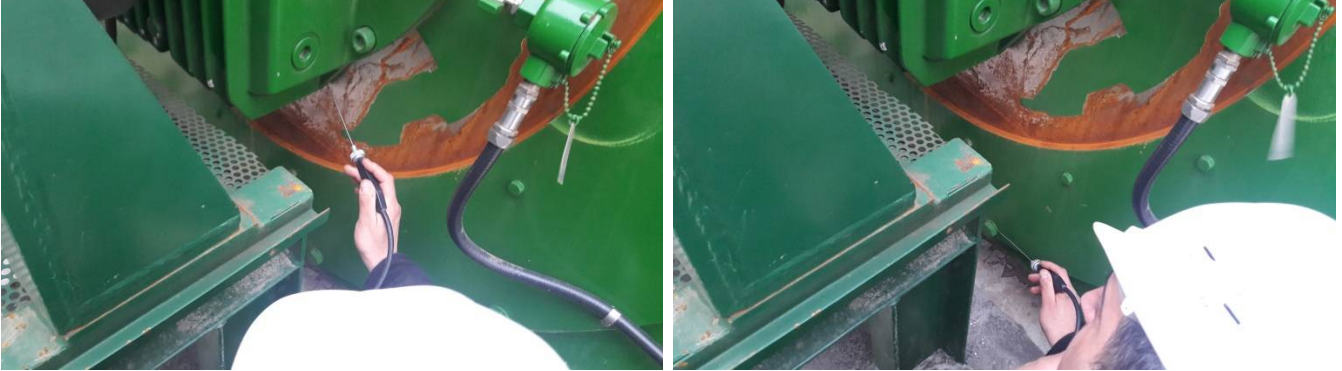
### HEADSET LISTENING

We listened to the voice of both bearing. There was not a problem for sound at the bearings.

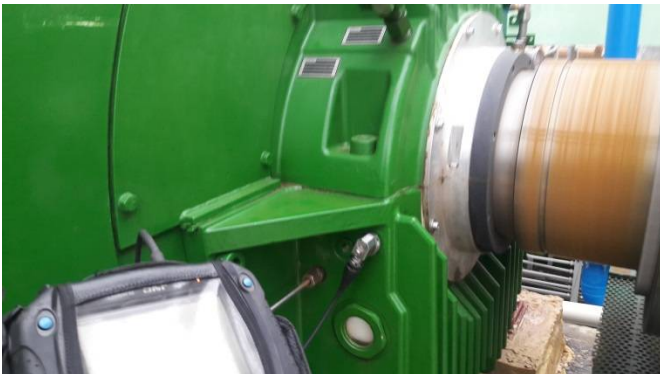
### VIBRATION ANALYSIS

<u>Machine name</u>	<u>POINT name</u>	<u>Date/Time</u>	<u>Last value</u>	<u>Units</u>	<u>POINT description</u>
Nidec-Karkey	MOTOR-HV	10.01.2016 12:57:05	0,967	mm/s	Insulated bearing side horizontal vibration (mm/sn RMS)
Nidec-Karkey	MOTOR-VV	10.01.2016 12:59:11	0,363	mm/s	Insulated bearing side vertical vibration (mm/sn RMS)
Nidec-Karkey	MOTOR-AV	10.01.2016 12:59:30	1,264	mm/s	Insulated bearing side axial vibration (mm/sn RMS)
Nidec-Karkey	MOTOR-NHV	10.01.2016 13:01:26	1,669	mm/s	Non insulated bearing horizontal vibration (mm/sn RMS)
Nidec-Karkey	MOTOR-NVV	10.01.2016 13:05:02	1,143	mm/s	Non insulated bearing vertical vibration (mm/sn RMS)
Nidec-Karkey	MOTOR-NAV	10.01.2016 13:05:23	1,399	mm/s	Non insulated bearing axial vibration (mm/sn RMS)

is not any problems for vibration measurement for bearing

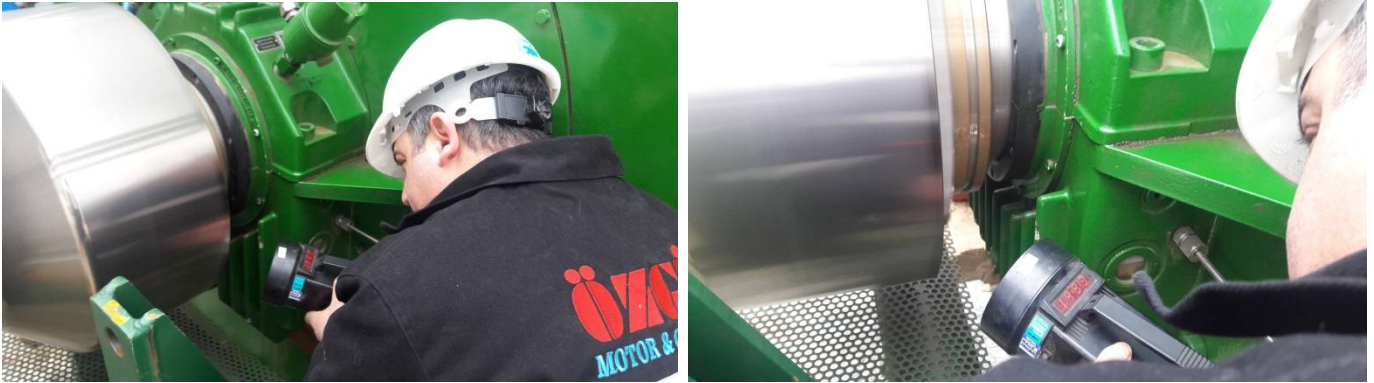
## STROBOSKOP CONTROL

is not any problems for stroboskop control for rotating shaft  
probably sound source as coupling
